HISTORIC U.S. 66 BRIDGE DATABASE 1926-1985

COMPILED BY JIM ROSS IN PREPARATION FOR THE BOOK: ROUTE 66 CROSSINGS: Historic Bridges of the Mother Road, published by THE UNIVERSITY OF OKLAHOMA PRESS. Periodic updates will denote bridges lost since its creation in 2015 with a red * asterisk.

NEW MEXICO

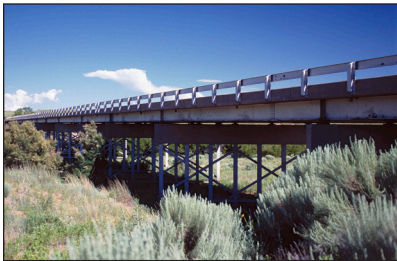
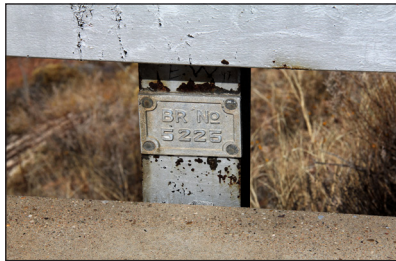
1. San Juan Creek Bridge on the 1950s upgrade route at Glenrio.

Date Built: 1952 (No. 5225).

Type: 12-span Steel Stringer.

Status: Closed to traffic; still in use in 1969 pending I-40 construction.

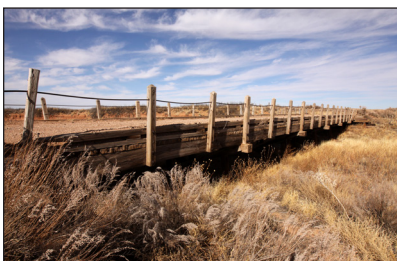
2. 1st Timber bridge on the 1926 route between Glenrio and San Jon.

Date Built: 1931

Type: Timber Stringer with asphalt deck; may have replaced an earlier bridge or LWC.

Status: Open to traffic.

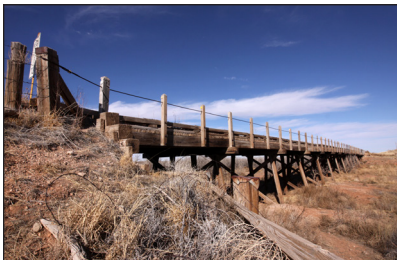
4. 3rd Timber bridge at Arroyo Trujillo on the 1926 route between Glenrio and San Jon.

Date Built: 1931

Type: Timber Stringer with asphalt deck; may have replaced an earlier bridge or LWC.

Status: Open to traffic.

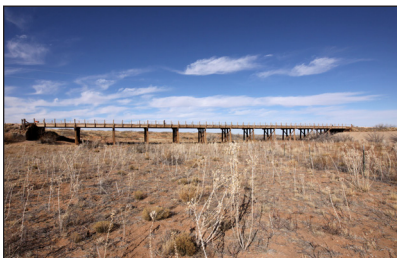
2013

5. 4th Timber bridge (on Trujillo Creek) between Glenrio and San Jon on an offset alignment.

Date Built: 1931 (this is an upgrade to the original route).

Type: Timber Stringer with asphalt deck.

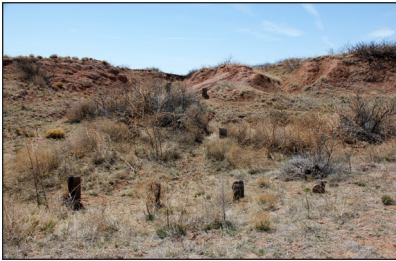
6. Remains of a timber bridge on the 1926 alignment south of the 1931 first paved route.

Date Built: Unknown

Type: Timber Stringer

Status: In ruins; limited access.

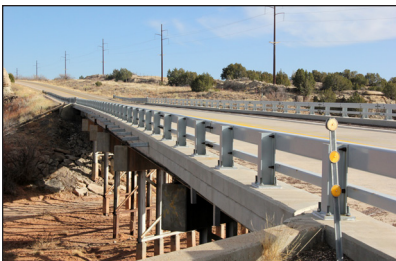
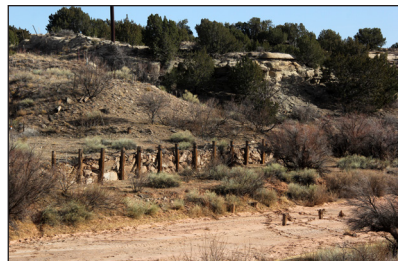
7. Bridge on Revuelto Creek west of San Jon.

Date Built: 1952 (No. 5232); new deck and guardrails constructed in 2004.

Type: 6-span Steel Stringer; replaced an early 1930s bridge to the south.

Note: Timber piers from the pre-1952 bridge still stand just south of the present bridge.

2013 (remains of earlier bridge)

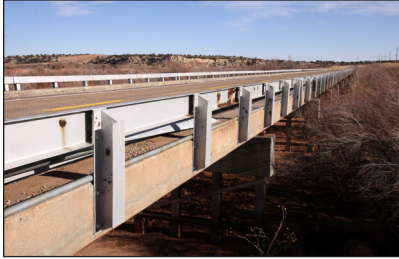
8. *Lost bridge on Plaza Larga Creek just west of the bridge listed above.

Date Built: 1952; replaced an early 1930s bridge to its immediate south.

Type: Steel Stringer (Bridge No. 5231).

Status: GONE. Replaced in 2021 with a new bridge at the site of its predecessor.

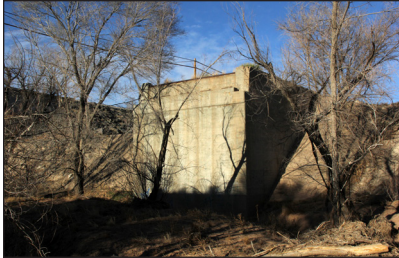
9. Lost Bluewater Creek Bridge on the 1926 route at the west end of Tucumcari.

Date Built: Circa 1930; replaced a bridge immediately to its north of unknown type or date.

Type: Unknown

Status: Only abutments remain; replaced by a Steel Stringer on an offset alignment in 1950.

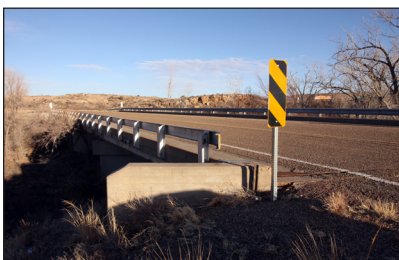
10. Steel Stringer on the upgrade alignment at the west end of Tucumcari on Blue Water Creek.

Date Built: 1950 (No. 3491).

Type: 3-span Steel Stringer.

Status: Open to traffic.

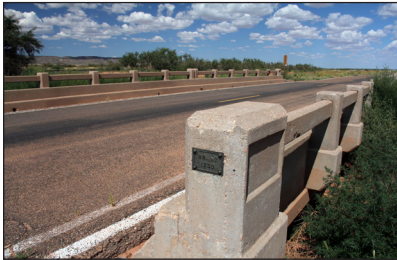
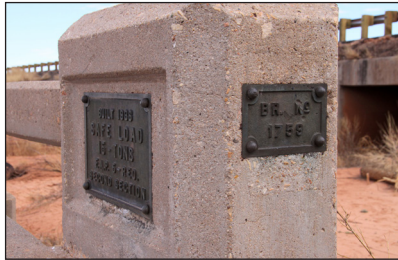
12. Steel beam on the 1926 route east of Montoya (3rd bridge east).

Date Built: 1936

Type: Steel Stringer

Status: Open to traffic. Plaque on the east end is missing; guardrails are damaged.

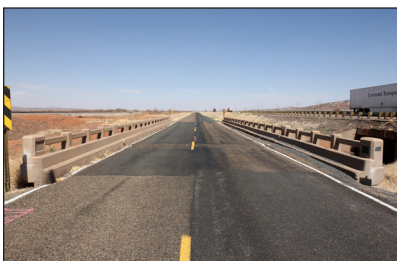
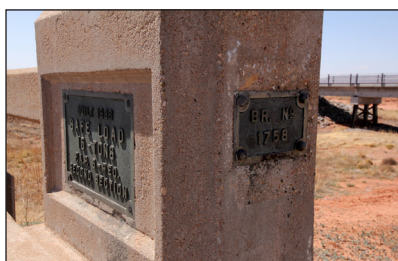
13. Steel Stringer on the 1926 route east of Montoya (2nd bridge east).

Date Built: 1936

Type: Steel Stringer with concrete guardrails.

Status: Open to traffic. Plaques on both ends are intact.

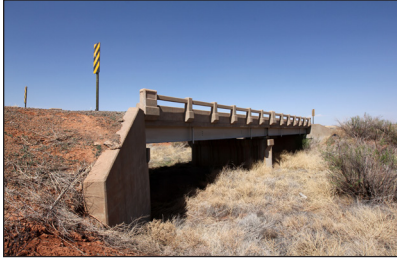
14. Bridge on Arroyo De Las Palomas on the 1926 route east of Montoya (1st bridge east).

Date Built: 1936

Type: Steel Stringer with concrete guardrails.

Status: Open to traffic. All plaques are missing.

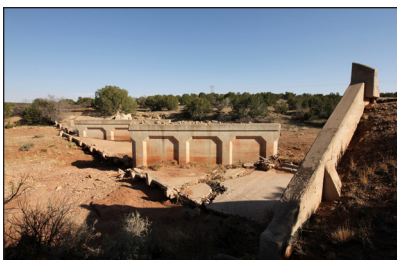
16. Bridge ruin on the abandoned 1926 route east of Newkirk.

Date Built: Circa 1936; replaced in 1951 with a Concrete Culvert on the current route (No. 5672) .

Type: Steel Stringer; piers approx. 13' tall; overall span approx. 100.'

Status: Abandoned; on private property.

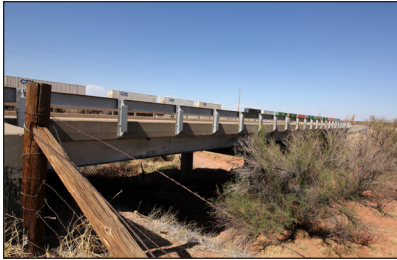
18. Pajarito Creek bridge on the 1950s route 1.2 mi. east of NM 129 at Newkirk.

Date Built: 1951 (No. 5237); replaced the bridge listed above.

Type: 3-span Steel Stringer with a bridge plaque on each end.

Status: Open to traffic.

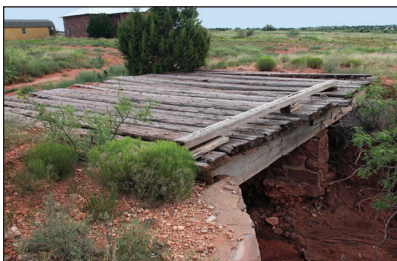
19. Timber bridge on an unnamed wash at Cuervo (1926 alignment).

Date Built: Unknown

Type: Single-span Timber bridge with one stone pier and combination stone & concrete abutments.

Status: Abandoned

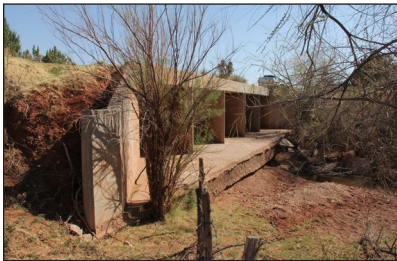
20. Cuervito Creek culvert on the first paved alignment (Cuervo Cutoff) west of Cuervo.

Date Built: Between 1931-1936.

Type: 5-barrel Concrete Culvert.

Status: Open to traffic; roadway not maintained.

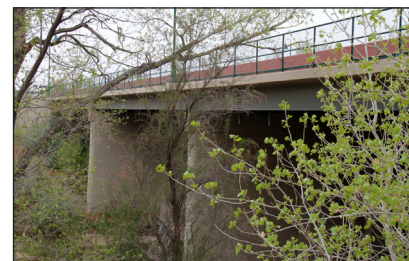
Status: 1959 bridge open to traffic.

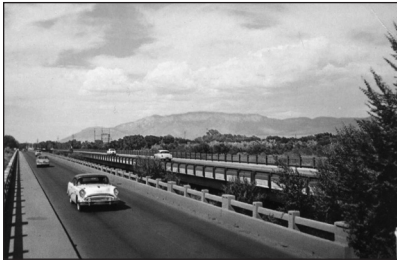
1930s bridges (WB bridge in foreground)

28. Lost Central Ave. bridges on the Rio Grande in Albuquerque (1937 upgrade route).

Date Built: EB bridge: Unknown; replaced the 1930s 2-lane bridge. The WB bridge was added in 1952 (this bridge may have been widened later). The current 4-lane bridge was built in 1983.

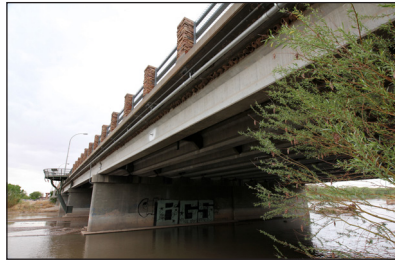
1983 bridge (2013 photo)

Status: GONE. Replaced in 1983 with a 4-lane Precast Concrete Girder.

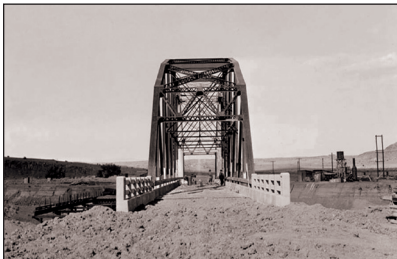
1933 construction photo

29. Rio Puerco Bridge west of Albuquerque on the 1937 alignment.

NOTE: Completion of the bridge above allowed for a section of what would become the 1937 Santa Fe Loop upgrade alignment to open as NM 6 between Albuquerque to Correo circa 1934. Prior to this, motorists could only travel west from Albuquerque to Correo via the primitive and unpaved NM 6.

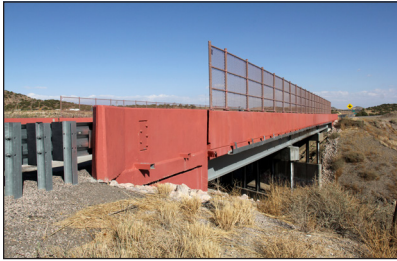
36. RR Viaduct just west of Old Laguna.

Date Built: 1955; replaced a 1932 span just to the east. A 1920s at-grade crossing was to the west.

2013 view of the 1955 RR Viaduct

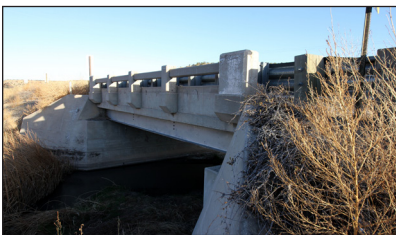
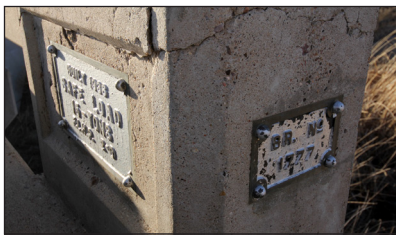
44. Steel beam bridge approx. 1000' west of the truss bridge listed above.

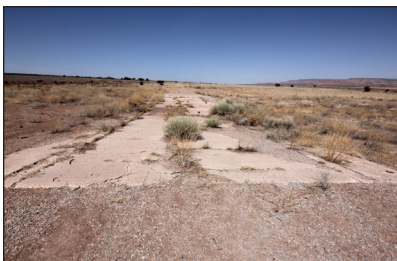
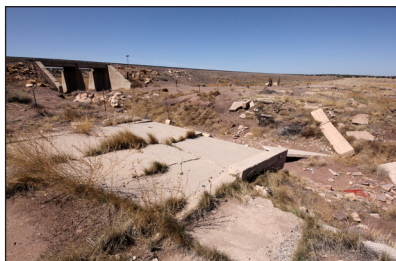
Status: Abandoned

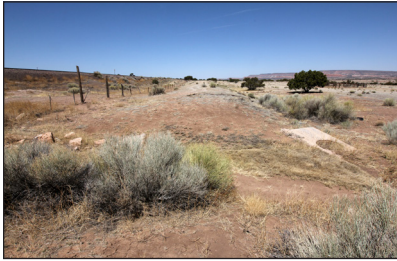
55. Ruins of a Tinhorn and concrete Culvert approx. $\frac{3}{4}$ mi. west of the 2nd LWC listed above.

Status: Abandoned

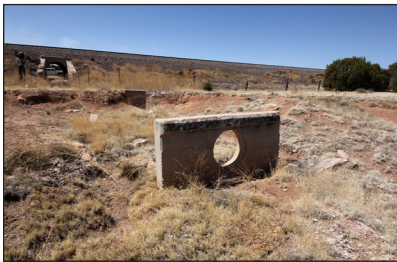
56. Culvert ruin on the north side of the RR west of Prewitt, approx. 1500' west of the above entry.

Type: Concrete and Tinhorn Culvert.

Status: Abandoned

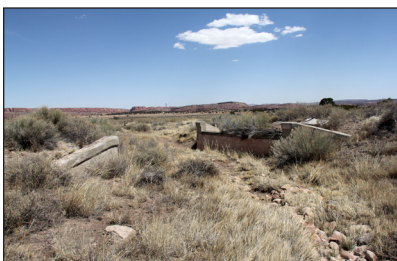
57. Bridge Ruin on the north side of the RR west of Prewitt, approx. 1 mi. west of the above entry.

Type: Timber with concrete abutments.

Status: Abandoned

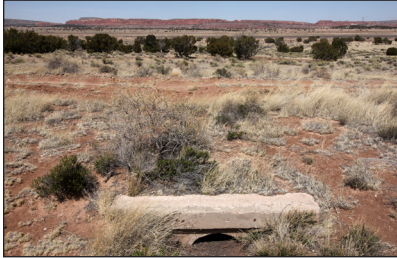
58. Culvert Ruin approx. 1200' west of the above entry.

Type: Concrete Culvert

Status: Abandoned

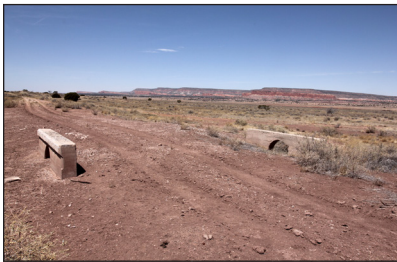
59. Tinhorn and concrete culvert 1000' west of the above entry.

Type: Concrete and Tinhorn Culvert.

Status: Abandoned

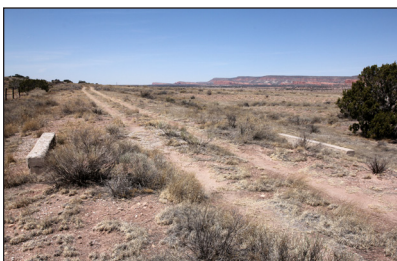
60. Tinhorn and concrete Culvert approx. 900' west of the above entry.

Type: Concrete and Tinhorn Culvert.

Status: Abandoned

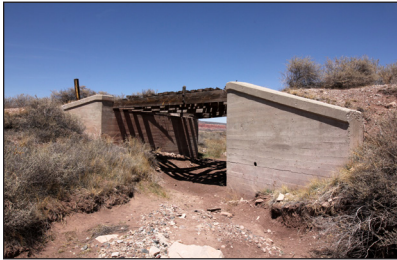
61. Bridge Ruin approx. 1500' west of the above entry.

Type: Timber with concrete abutments.

Status: Abandoned.

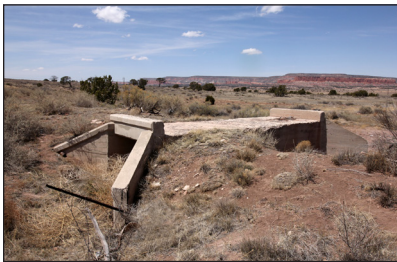
62. Concrete Culvert approx. 1200' west of the above entry.

Type: Concrete Culvert with wing walls.

Status: Abandoned

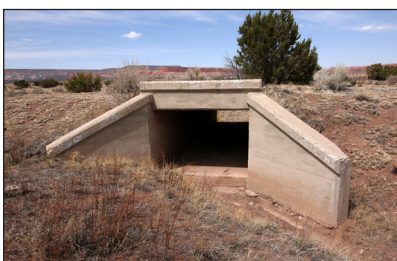
63. Concrete Culvert approx. 3/4 mi. west of the above entry.

Type: Concrete Culvert with guardrails and wing walls.

Status: Abandoned

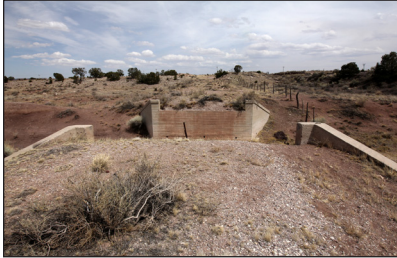
64. Bridge ruin approximately .4 mi. west of the above entry.

Type: Timber with concrete abutments; only the abutments remain.

Status: Abandoned

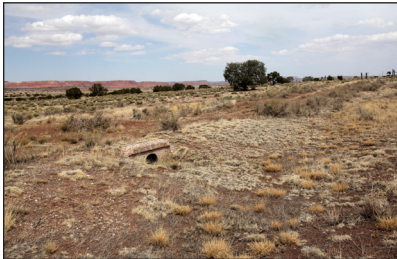
65. Culvert approximately .6 mi. west of the above entry (2 mi. east of Thoreau).

Type: Concrete and Tinhorn Culvert.

Status: Abandoned

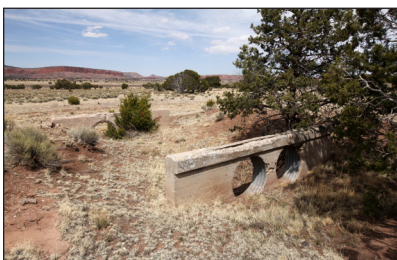
66. Concrete and Tinhorn Culvert approx. 1000' west of the above entry (east of Thoreau).

Type: 2-barrel Tinhorn and Concrete Culvert.

Status: Abandoned

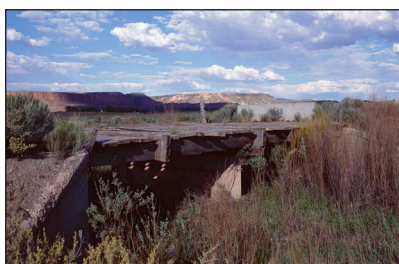
Status: Abandoned; only some timber remains.

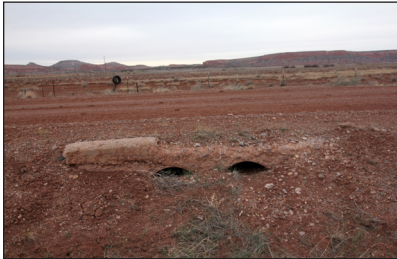
73. Tinhorn and concrete Culvert 2.2 mi. west of the bridge ruin listed in the above entry.

Status: Open to traffic (this portion of the roadway is still in use).

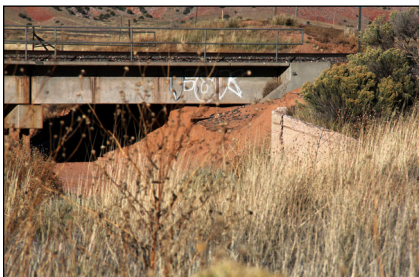
Type: Unknown. Replaced by a concrete culvert on the 1937 first paved alignment nearby.

Status: Only the concrete abutments remain.

2017 (abutment: right foreground)

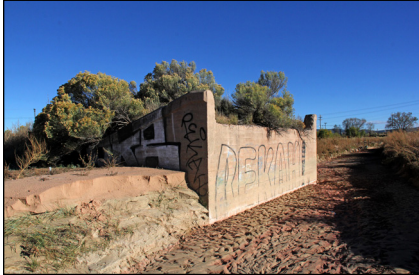
76. Lost bridge on the 1926 route east of the NM 566 turnoff east of Gallup.

Type: Unknown. Replaced by the entry below on the nearby upgrade alignment.

Status: Only the concrete abutments remain.

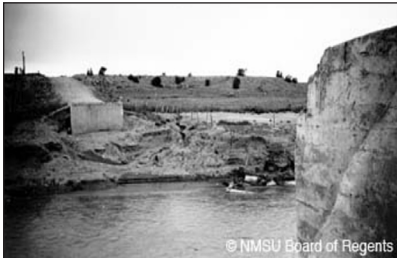
Following the 1937 flood

Status: GONE. Destroyed by a flood in 1937 (the same year the Santa Fe Loop was bypassed).

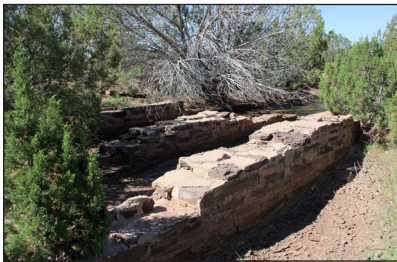
2. Stone Culvert west of US 84 on the 1926 route north of Dilia. Documents the path of US 66.

Status: In ruins; closed to traffic; on private property.

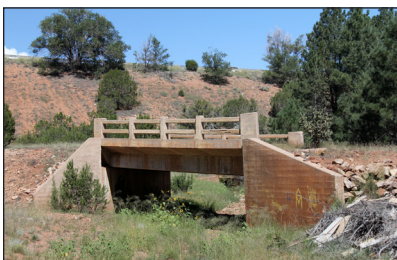
3. Abandoned concrete bridge on the 1926 route at Romeroville.

Status: Closed to traffic; limited access.

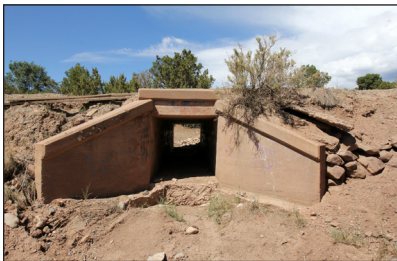
2013 (culvert A)

Status: A & B open to traffic; C is on private property.

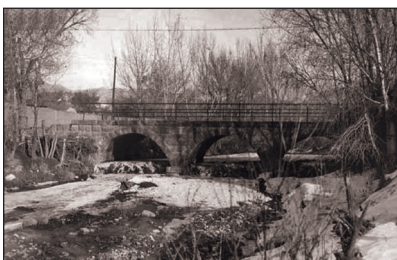
Status: GONE. Replaced in 1986 with a Concrete Slab.

13. Lost bridge over the Santa Fe River on Galisteo St. in Santa Fe.

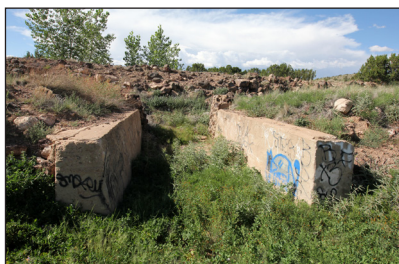
16. Lost bridge on Alamo Creek on the 1932 upgrade route (I-25 Svc. Rd. 1 mi. WB from Exit 271).

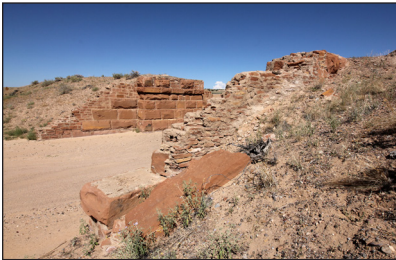
22. Bridge ruin on the 1926 route (formerly the RR) 4 mi. west of the RR viaduct noted above.
Date Built: Unknown; built for the RR that predated Route 66.

Status: Stone abutments remain; the nearby highway is post-66 era for this route.

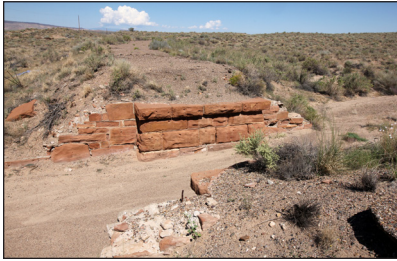
Status: Abutments remain; access limited; bypassed in the post-66 era for this route.

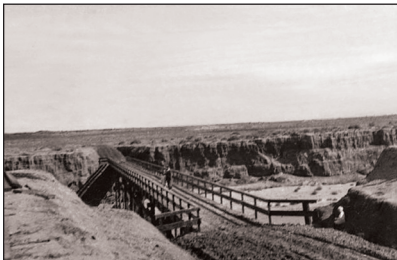
Status: GONE. Replaced in the post-66 era for this alignment.

26. *Lost Timber Bridge 2.5 mi. east of Correo on NM 6 (1926-1937 route).
