HISTORIC U.S. 66 BRIDGE DATABASE 1926-1985

COMPILED BY JIM ROSS IN PREPARATION FOR THE BOOK: ROUTE 66 CROSSINGS: Historic Bridges of the Mother Road, published by THE UNIVERSITY OF OKLAHOMA PRESS. Periodic updates will denote bridges lost since its creation in 2015 with a red * asterisk.

TEXAS

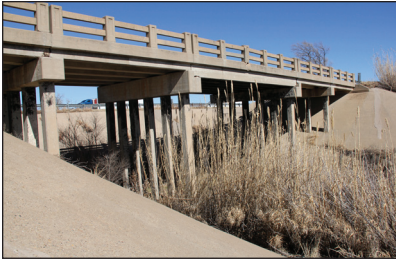
1. Concrete bridge over an abandoned RR 5.5 mi. west of the Oklahoma State Line.

Type: Concrete Deck Girder.

Status: Open to traffic.

Note: Added to the NRHP in April 2007.

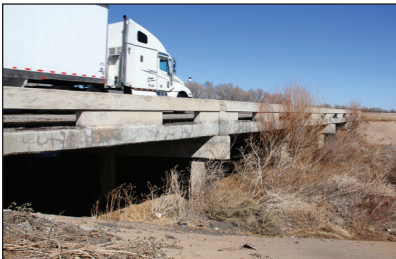
2. *Lost bridges on North Long Dry Creek 2 mi. west of Lela (south Service Rd. and EB I-40).

Type: Concrete Slabs. The south service road bridge replaced a 1930s bridge of unknown type on the first paved 2-lane route. (The original 2-lane just to the south had 3 creek crossings in the area.)

Status: GONE. Replaced circa 2018. Dates and types of original 2-lane bridges are unknown.

2013 (EB I-40 bridge)

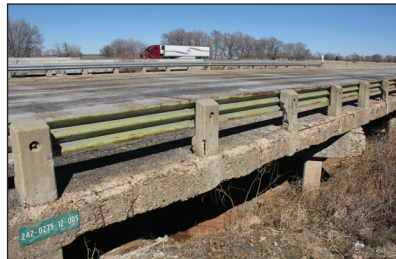
2013 (EB I-40 Service Rd. bridge)

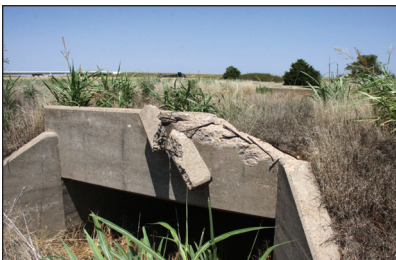
3. Abandoned Concrete Culvert on first paved 2-lane route just west of McLean.

Type: Concrete Culvert

Status: Abandoned

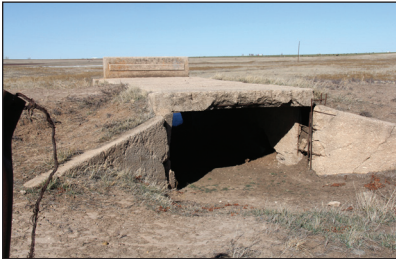
Type: Concrete Culverts (2 with guardrails).

2013 (1st culvert WB)

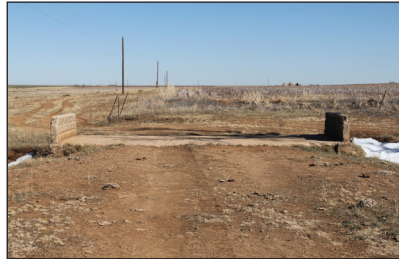
2013 (2nd culvert WB)

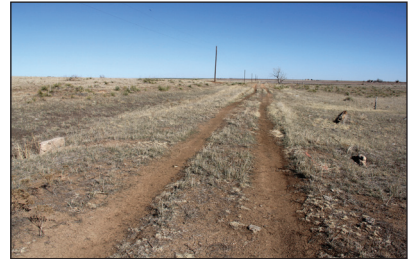
2013 (3rd culvert WB)

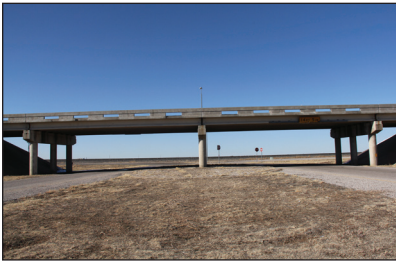
5. East Amarillo Blvd. bridge over "Ave. B" near the airport (EB lanes; there is no WB bridge).

Type: 4-span Precast Concrete Girder.

Status: Open to traffic.

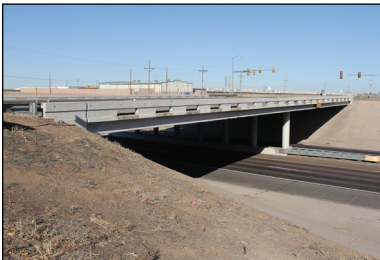
6. East Amarillo Blvd. bridges over Lakeside Dr.

Type: Concrete Slabs

Status: Open to traffic.

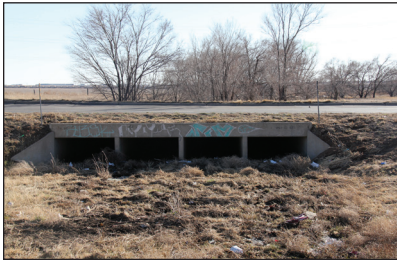
7. Concrete Culverts on Amarillo Blvd. (eastbound and westbound) near the RR underpass.

Type: 4-barrel Concrete Culverts.

Status: Open to traffic.

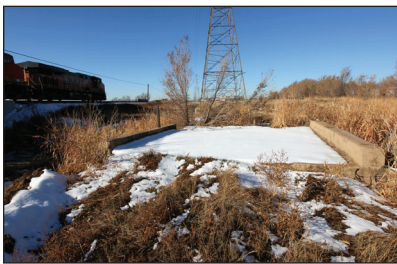
8. Slab bridge on the 1926 route near the RR underpass on East Amarillo Blvd.

Type: Single-span Concrete Slab (18' wide).

Status: Abandoned

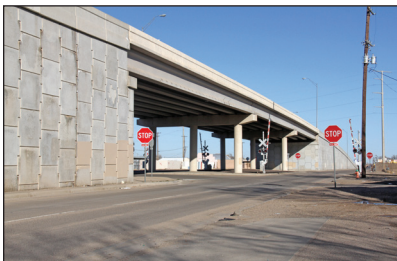
9. RR viaduct on Amarillo Blvd. just west of Panhandle Blvd.

Type: 3-span Precast Concrete Girder.

Status: Open to traffic.

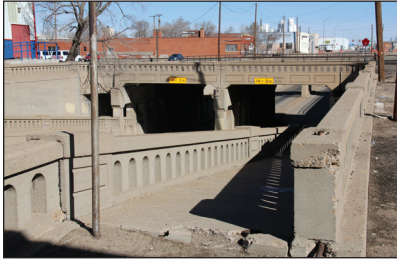
10. RR Underpasses with art deco walkways on Fillmore St. in Amarillo (original route).

Date Built: 1931; prior to this it would have been an at-grade crossing.

Type: Steel Beam and Concrete.

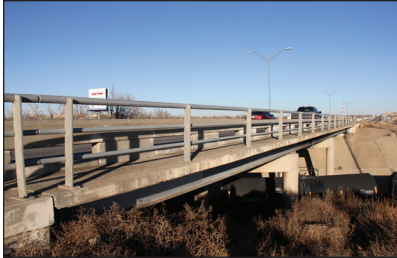
11. *Lost Twin RR Viaducts on West Amarillo Blvd. just east of Lamar.

Type: Steel Stringers

Status: GONE. Replaced in 2022.

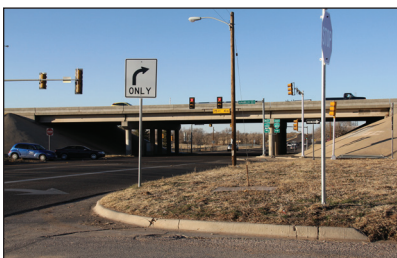
12. Bridge on West Amarillo Blvd. over Western Avenue.

Type: Precast Concrete Girder.

Status: Open to traffic.

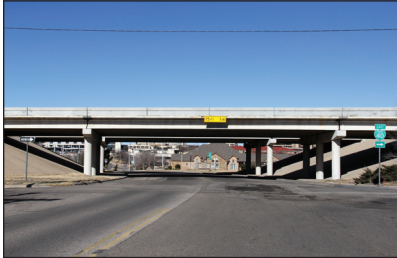
13. Amarillo Blvd. bridges over Hagy St.

Type: Precast Concrete Girders.

Status: Open to traffic.

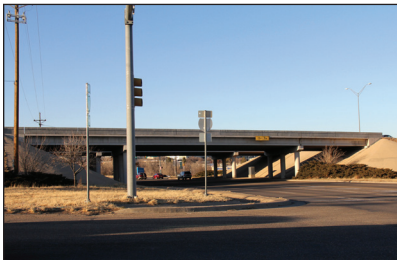
14. Twin Bridges on Amarillo Blvd. over Coulter Street.

Type: Precast Concrete Girders.

Status: Open to traffic.

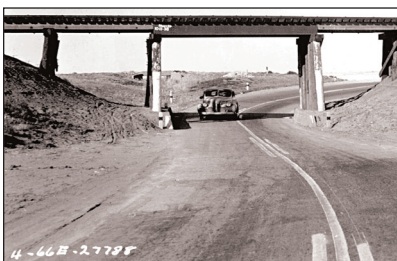
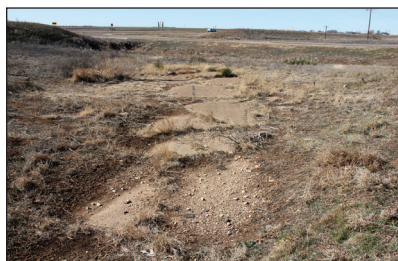
15. Acknowledgment of an integral structure (subway under the RR) on the west side of Amarillo.

Type: Timber and Steel Beam trestle.

Status: GONE. Replaced with an at-grade crossing; RR tracks have since been removed.

Note: a fragment of curved paving remains on the right of way at the location.

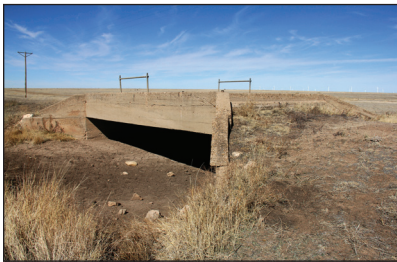
16. Concrete bridge (1st west of Vega) on the 1926 route north of the former RR.

Type: Concrete Deck Girder with iron guardrails.

Status: Abandoned; on private property.

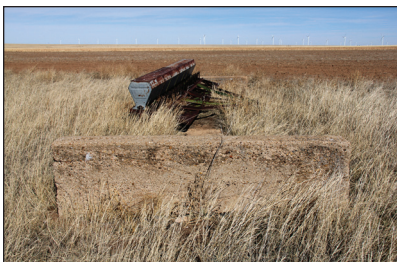
17. Concrete Culvert (2nd west of Vega) on the 1926 route, approx. 2 mi. west of No. 16 above.

Type: Concrete Culvert

Status: Abandoned; on private property.

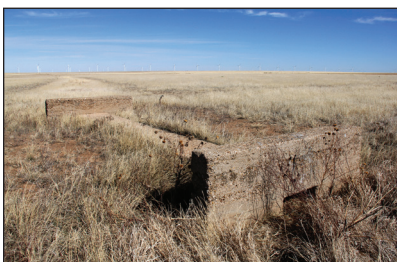
18. Concrete Culvert (3rd west of Vega) on the 1926 route, 1000 ft. west of No. 17 above.

Type: Concrete Culvert

Status: Abandoned; on private property.

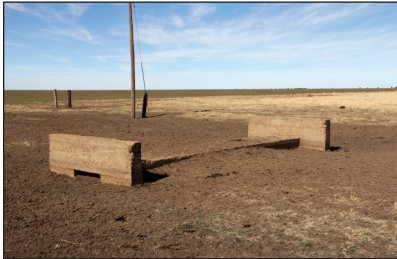
19. Concrete Culvert (4th west of Vega) on the 1926 route, approx. 2.3 mi. west of No. 18 above.

Type: Concrete Culvert

Status: Abandoned; on private property.

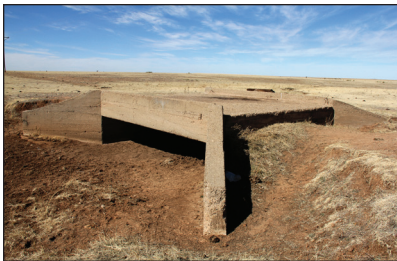
20. Concrete bridge (5th west of Vega) on the 1926 route, approx. 2.7 mi. west of No 19 above.

Type: Concrete Slab

Status: Abandoned; on private property.

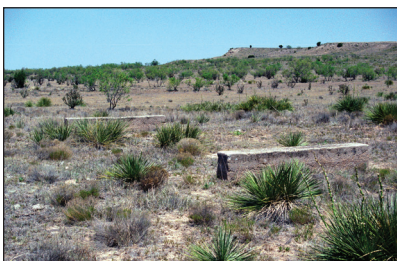
21. Concrete Culvert on the 1926 route west of Adrian on the north side of I-40's Ivy Rd. Exit.

Type: Concrete Culvert

Status: Abandoned; on private property.

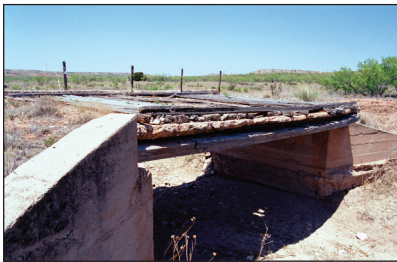
23. Timber bridge on the 1926 route south of I-40's Ivy Rd. Exit westbound from the entry above.

Type: Timber with concrete abutments.

Status: Abandoned; in ruins.

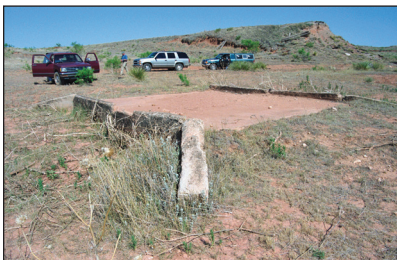
24. Concrete Culvert on the 1926 route southwest of I-40's Ivy Rd. Exit on the Boydston Ranch.

Type: Concrete Culvert

Status: Abandoned; on private property.

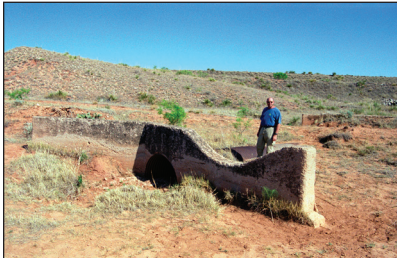
25. Tin Culvert with concrete supports on the 1926 route east of Boise.

Type: Tin Culvert with concrete supports.

Status: Abandoned; on private property.

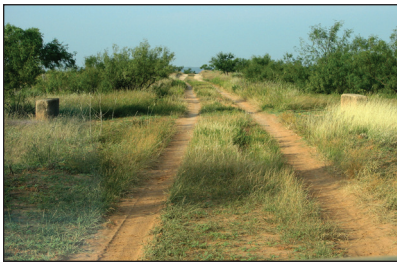
26. Concrete Culvert on the 1926 route on the Bridwell Ranch west of Boise.

Type: Concrete Culvert

Status: Abandoned; on private property.

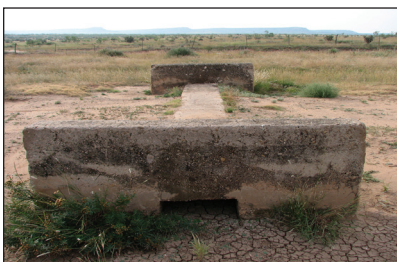
27. Concrete Culvert on the 1926 route on the Bridwell Ranch west of Boise.

Type: Concrete Culvert

Status: Abandoned; on private property.
