Between Chicago (east)
and Joliet (west)

Note on RR Crossing at Cicero Avenue:

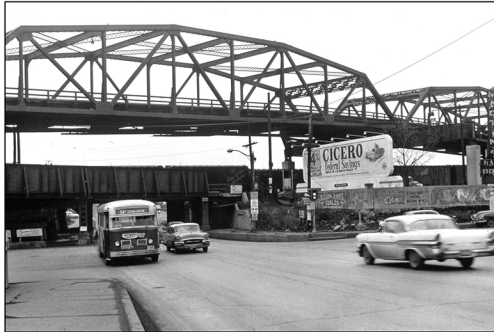
1950s photo of the 1938 RR overpasses for US 66 in Cicero. View is looking south on Cicero Ave. The crossing street is 25th Place.

The original green/red alignment on Ogden Ave. crossed the RR via two 90-degree turns at Cicero Ave. In 1938, a massive overhead was built (orange, and photo at left), consisting of two large steel truss spans and 22 additional mixed truss spans that separated Ogden Ave./US 66 from the tracks. A portion of the newly-elevated Ogden Ave. on the east side of Cicero Ave. was divided. Traffic on Cicero Ave. passed under a trestle (visible in photo). In 1999, the bridges were removed, and the road reconfigured as depicted (gray).
