HISTORIC U.S. 66 BRIDGE DATABASE 1926-1985

COMPILED BY JIM ROSS IN PREPARATION FOR THE BOOK: ROUTE 66 CROSSINGS: Historic Bridges of the Mother Road, published by THE UNIVERSITY OF OKLAHOMA PRESS. Periodic updates will denote bridges lost since its creation in 2015 with a red * asterisk.

ILLINOIS

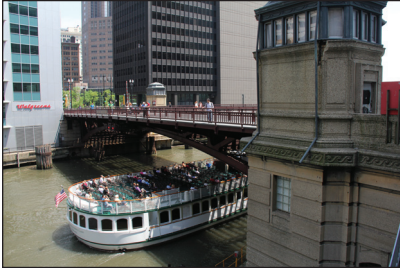
2013

1. Chicago River Bridge downtown Chicago on Jackson Blvd. (one-way EB).

Date Built: 1915

Type: Double Trunnion Bascule Deck Truss.

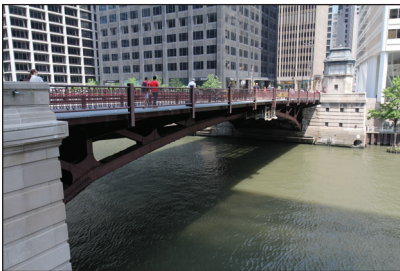
2013

2. Chicago River Bridge downtown Chicago on Adams Ave. (one-way WB).

Date Built: 1927; rehabbed in 1996.

Type: Double Trunnion Bascule Deck Truss.

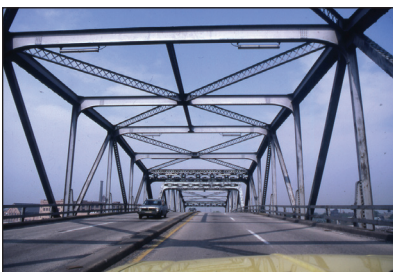
Jerry McClanahan Photo circa 1985

3. Lost RR Viaduct on Ogden Ave. in Cicero (Ogden at Cicero Ave.).

Date Built: 1938 (No. 016-0228); rehabbed in 1959; removed in 1999.

Type: 24-span mix of Pony and Warren Through Truss with Verticals.

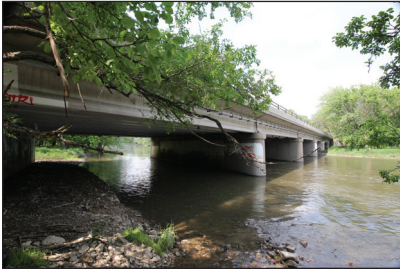
4. Des Planes River Bridge on Joliet Rd., just west of Harlem in Lyons.

Date Built: 1900; replaced in 1927; rehabbed in 1996.

Type: 5-span Precast Concrete Girder.

2013 view of 1996 rehabilitation

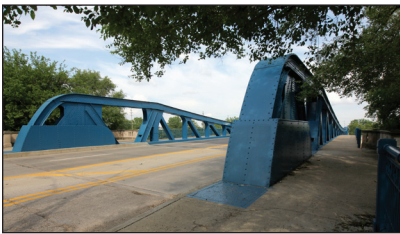
2013

5. Ruby St. Bridge on the Des Plaines River in Joliet.

Date Built: 1935 (No. 099-9901); rehabbed in 1972.

Type: Double Trunnion Bascule Deck Truss.

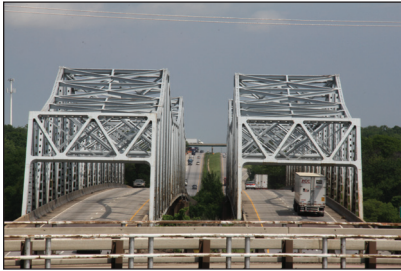
2013

6. Twin I-55 bridges on the Des Plaines River south of Joliet.

Date Built: 1957 for 4-lane US 66; rehabbed in 1997. Replaced a 1932 bridge to their immediately east.

Type: Cantilevered Warren Through Truss.

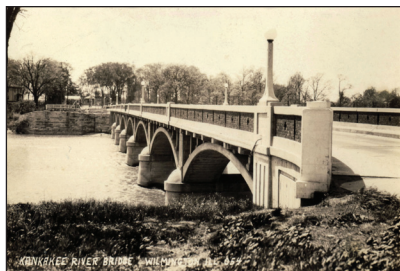
Type: (1) Pratt Through Truss; (2) 7-span Open-Spandrel Concrete Arch.

1930s Concrete Arch

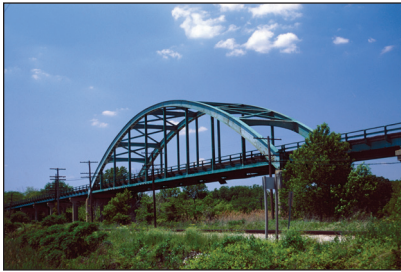
1995

10. Lost Steel Arch Bridge over the RR between Braceville and Gardner on IL 129.

Date Built: 1939 (No. 032-0062); reconstructed 1964.

Type: Tied Steel Through Arch.

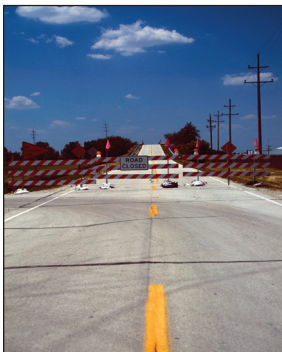
1999

12. Lost Viaduct at Gardner on IL 53 over the Union Pacific RR.

Date Built: 1928; reconstructed 1965; closed 11-19-98.

Type: 1928 = Unknown (No. 032-0022); reconstructed in 1965 as Steel Girder with Precast Concrete Girder approaches.

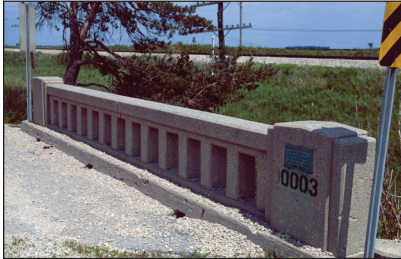
1999

13. Lost bridge on Woods Run Creek 2 mi. south of the RR viaduct at the south edge of Gardner.
Date Built: 1954 (No. 032-0003); would have replaced an earlier bridge on the 1926 route.

Type: Concrete Slab

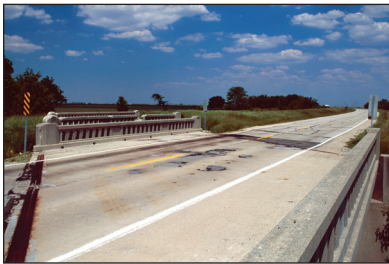
1999

14. Lost Gooseberry Creek bridges just north of Dwight on the 4-lane bypass alignment.

Type: Original EB = unknown; 1954 EB replacement = Concrete Deck Girder; 2000 EB replacement = concrete culvert ; WB = unknown, likely a Concrete Deck Girder.

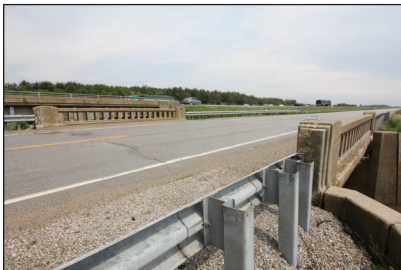
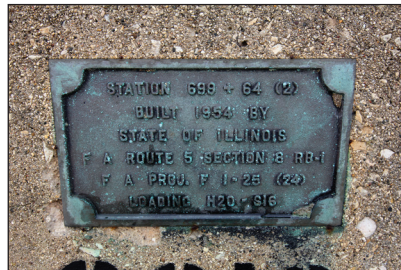
2013

17. Mazon River Bridge north of Odell on the original 2-lane alignment.

Date Built: 1954 (No. 053-0013); replaced an earlier bridge of unknown date and type.

Type: Concrete Deck Girder (Tee Beam).

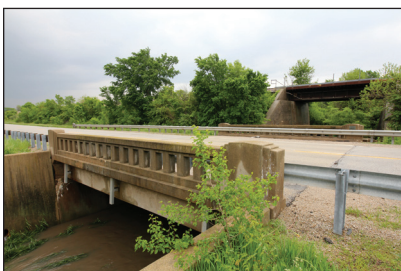
2013

18. Concrete Girder on Wolf Creek at Cayuga (north of Pontiac).

Date Built: 1955 (No. 053-0011); replaced an earlier span of unknown date and type; rebuilt in 1998.

Type: Concrete Deck Girder.

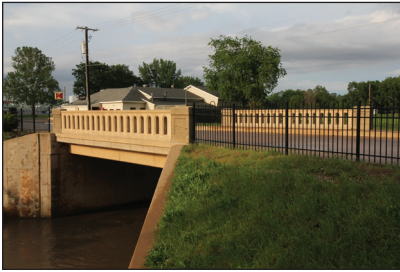
2013

20. Bridge on N. Division St. (2-lane route) over North Creek, Pontiac.

Date Built: 1926 (No. 053-0073); rebuilt in like style in 2005 (No. 053-7105), re-using original end posts.

Type: Concrete Deck Girder.

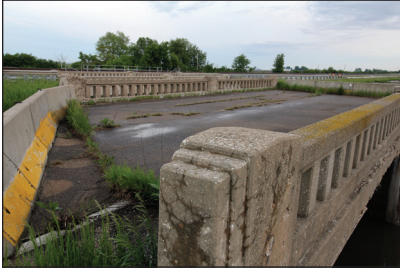
23. Slab bridges on 4-lane US 66 on Turtle Creek south of Pontiac.

Type: EB (No. 053-0005) = Concrete Slab; WB (No. 053-0006) = Concrete Slab.

2013 (the closed 1943 WB bridge)

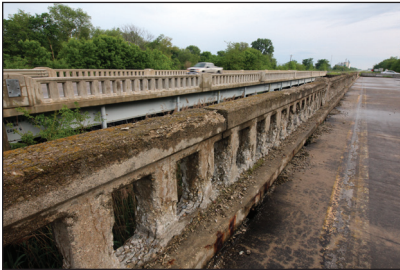
2013

24. Twin bridges on Rooks Creek south of Pontiac.

Date Built: EB (No. 053-0003) = 1940 (replaced an earlier bridge on a dangerous curve); rebuilt in 1997; WB (No. 053-0004) = 1946 for the 4-lane expansion; closed in 1998.

Type: Both are Steel Stringers.

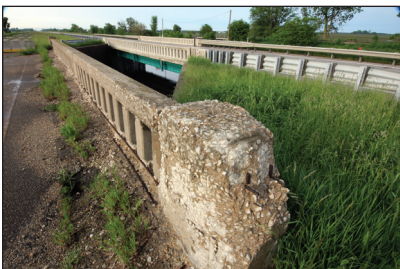
2013

25. Side by side bridges north of Chenoa on a tributary to Rooks Creek on 4-lane US 66.

Date Built: WB = 1943 (No. 053-0001) for 4-lane expansion; closed in 1998. EB = 1954 (No. 053-0002), which replaced an earlier bridge on the original 2-lane. The 1954 EB bridge was rebuilt in 2001.

Type: WB = Concrete Deck Girder; EB = Unknown; 2001 EB replacement = Steel Beam.

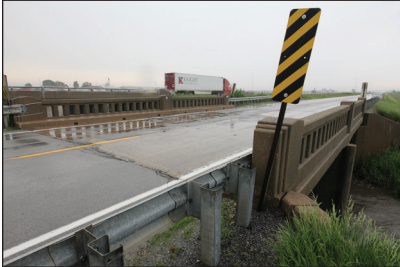
2013

26. *Lost Concrete bridge on Turkey Creek north of Lexington.

Date Built: 1954 (No. 057-0039); replaced a bridge of unknown date and type on the original 2-lane.

Type: Concrete Slab; the WB bridge built for the 4-lane expansion was consumed by EB I-55.

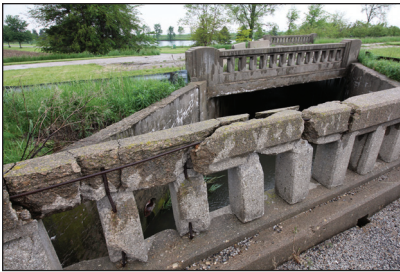
2013

27. *Lost bridges on the north side of Lexington (south of No. 26 above) on the 4-lane route.

Date Built: WB (built for 4-lane expansion) = 1945 (No. 057-0038); EB = 1954 (No. 057-0037).

Type: Both are Concrete Slab. EB replaced a bridge on original 2-lane; WB bridge is closed.

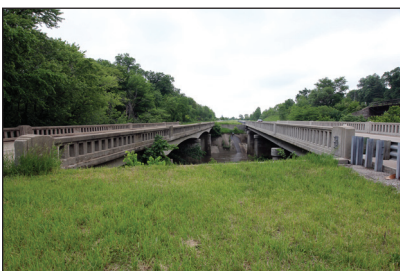
2013

28. Bridges on the Mackinaw River just south of Lexington.

Date Built: EB (original 2-lane route): 1954 (No. 057-0035); replaced an earlier bridge; rebuilt in 2000;

WB (No. 057-0036) = 1946 for the 4-lane expansion.

Type: 1954 and Prior EB bridges = Unknown; 1954 was likely a Concrete Deck Girder; 2000 bridge = Precast Concrete Girder; WB (1946) = Continuous Concrete Deck Girder (4 beams across).

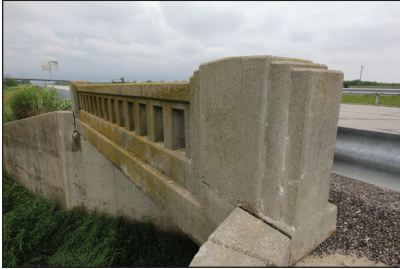
2013

29. Slab bridge on the original 2-lane alignment (EB half of 4-lane) north of Towanda.
Date Built: 1954 (057-0033); would have replaced an earlier bridge.
Type: Concrete Slab
Status: Open to 2-way traffic; WB bridge consumed by EB I-55.
Coordinates: 40.606537,-88.836155

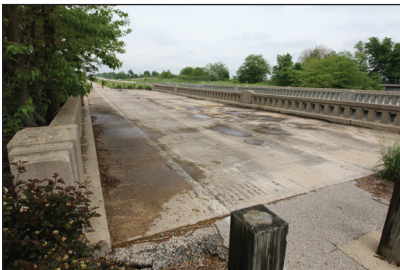
2013

30. Bridges on Money Creek on 4-lane US 66 on the north side of Towanda.
Date Built: EB (No. 057-0031):1954 (replaced earlier bridge of unknown date and type); replaced in 2000 (No. 057-0239); WB (No. 057-0032): 1945 for the 4-lane expansion.
Type: 1954 EB = Continuous Concrete Deck Girder; 1945 WB = Continuous Concrete Deck Girder.
Status: EB (orig. 2-lane path) open to traffic; WB bridge closed. Coordinates: 40.572937,-88.885269

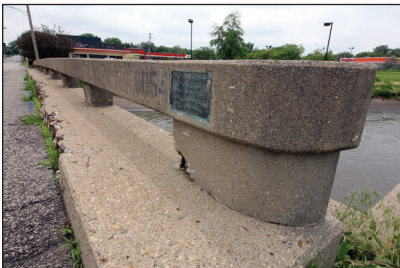
2013

31. *Lost Sugar Creek Bridge on Main St. just north of Virginia in Bloomington (EB).
Date Built: 1917 (No. 057-0054); rebuilt in 1954.
Type: Concrete Slab; retained its original bridge number; piers were likely original to 1917.
Status: GONE. Replaced circa 2018.
Coordinates: 40.49868,-88.994427

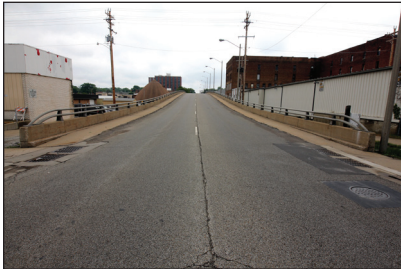
Eastbound 2013

32. RR Viaducts in downtown Bloomington (EB on Main St.; WB on Center St.).

Date Built: EB (No. 057-0193) on original pathway = 1981, may have replaced an earlier bridge;
WB (No. 057-6301) = 1970 (rebuilt 2004).

Type: Steel Girder.

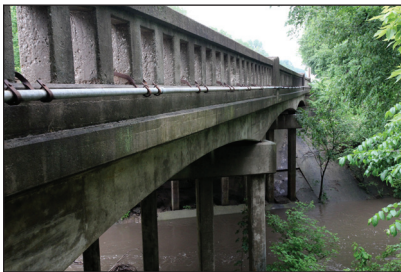
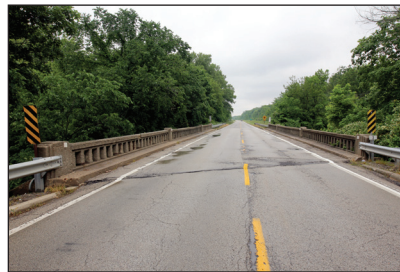
2013

33. Lost Concrete Girder on Timber Creek at Funk's Grove.

Date Built: 1954 (No. 057-0003); would have replaced the earlier bridge acknowledged above.

Type: 3-span Continuous Concrete Deck Girder (4 beams across).

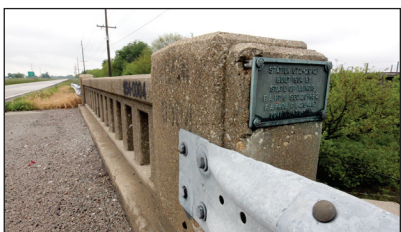
2013

34. Slab bridge on the WB half of 4-lane US 66 (original 2-lane) on Clear Creek north of Atlanta.

Date Built: 1954; would have replaced an earlier bridge of unknown date and type.

Type: Concrete Slab; one guardrail has been removed.

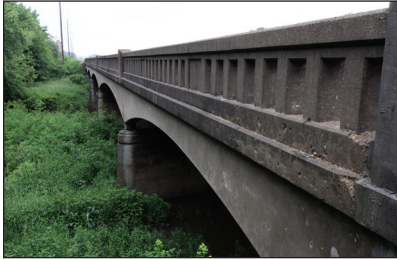
2013

35. *Lost Concrete bridge on Kickapoo Creek just north of Lawndale.

Date Built: 1954 (No. 054-0002); would have replaced an earlier bridge of unknown date and type.

Type: Five-span Continuous Concrete Deck Girder.

Note: Bridge was on the WB half of 4-lane 66 (original 2-lane). EB half of 4-lane 66 is under I-55.

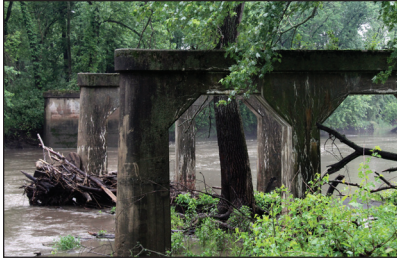
2013

36. Lost Salt Creek Bridge at Lincoln.

Date Built: Circa 1920s; replacement bridge built in 1942 on offset alignment.

Status: GONE. Only piers remain.

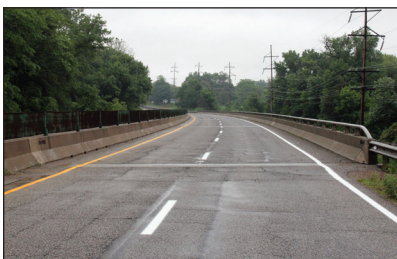
2013

37. Lost Salt Creek Bridge on current alignment at Lincoln.

Date Built: 1942 (No. 054-0005); reconstructed in 1975.

Type: Steel Girder

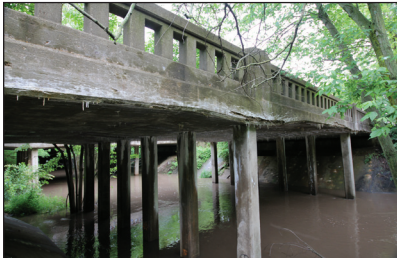
38. Bridges on Fancy Creek (formerly 4-lane US 66) at the north end of Sherman.

Date Built: EB (No. 084-0031) = 1953 (original 2-lane; replaced earlier bridge). WB (added for 4-lane 66); likely built in 1953 also.

Type: Both are nearly identical Concrete Slabs.

2012 Abandoned westbound bridge

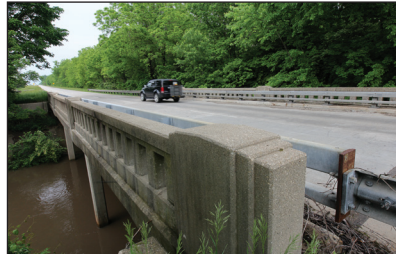
2012 Eastbound bridge

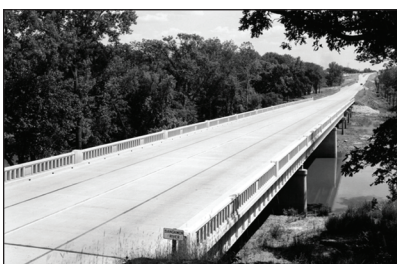
Date Built: Circa 1900s; replaced 1936.

Note: IDOT bridge report lists 1926 date in error; IL Historic Registry and other sources list 1936.

IDOT photo of 1936 bridge

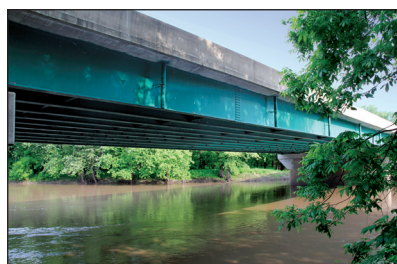
2013 Reconstructed bridge

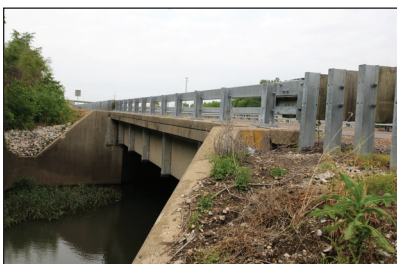
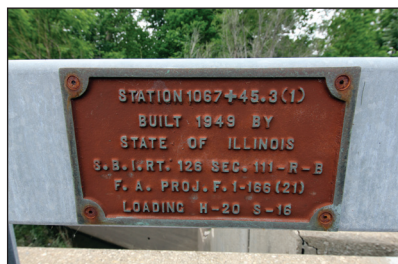
2013

47. Concrete bridge on Macoupin Creek at Farmersville.

Date Built: 1949 (No. 068-0054); replaced an earlier bridge to the immediate west on an offset alignment (fragmented concrete roadbed remains in both directions from the creek).

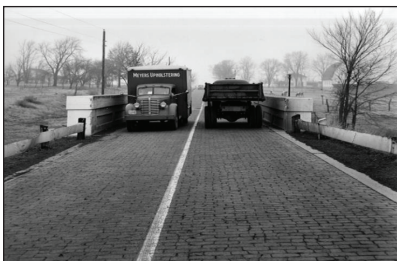
Circa 1940s

55. Lost bridge on Panther Creek north of Auburn on Curran Road.

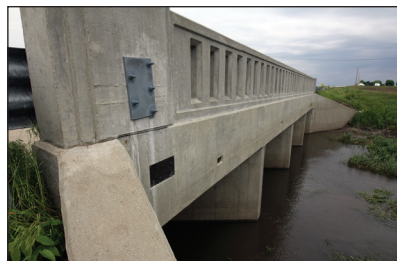
Status: GONE. Replaced 2002 (No. 084-0501).

2013 view of 2002 bridge

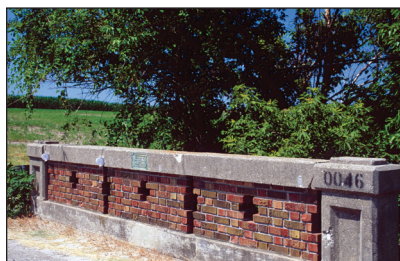
2013

Type: Concrete Slab with brick guardrails; Replacement = Concrete Culvert with brick guardrails.

Status: GONE. Replaced 2010 (No. 059-2502).

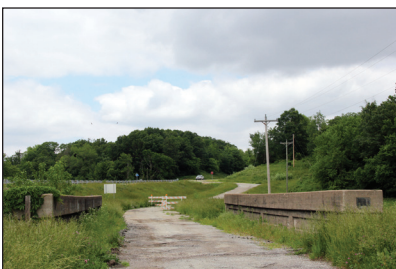
2013

62. Girder bridge on Honey Creek on Deerfield Dr. south of Carlinville, east side of the current Hwy.

Status: Closed to traffic.

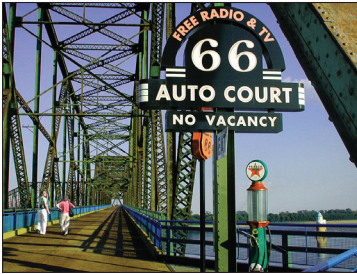
2003 Shellee Graham photo

68. Chain of Rocks Bridge on the Mississippi River (1936 route).

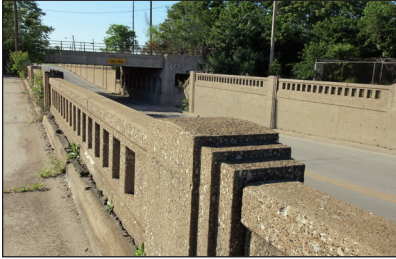
2013

74. RR Tunnel / Underpass #1 on St. Clair Ave. (IL 3 route between Venice and East St. Louis).

Note: This was US 66 from 1929-1936. It is possible that the underpass was built after 1936.

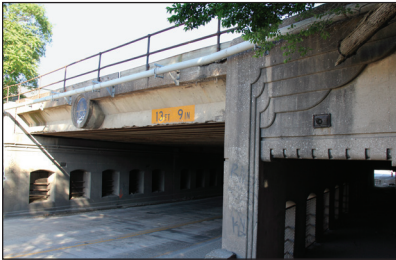
2013

75. RR Tunnel / Underpass #2 on St. Clair Ave. (IL 3 route between Venice and East St. Louis).

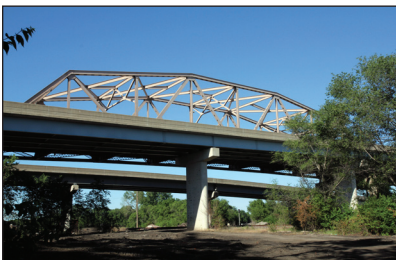
2013

76. *Lost MLK/Veterans Approach Bridge in East St. Louis over the RR and Missouri Ave.

Status: GONE. Replaced circa 2018 with a Steel Girder.

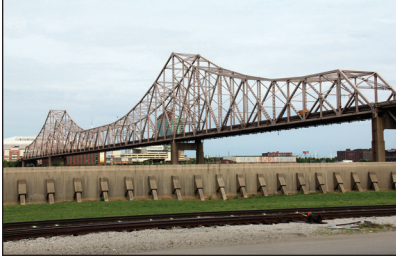
2013

77. MLK / Veterans Bridge on the 1956 route (Collinsville Rd. / 9th St. / MLK).

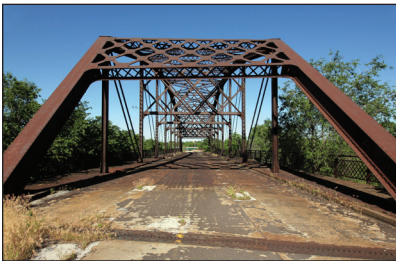
2013

78. Approach Bridge to Municipal / Douglas MacArthur Bridge in East St. Louis (1929 route).

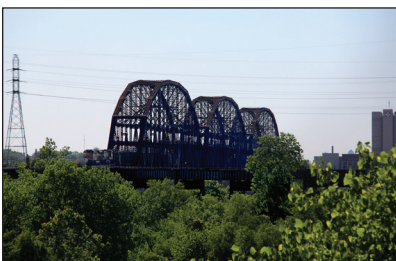
2013

79. Municipal / Douglas MacArthur Bridge (1929 route from East St. Louis, IL).
